FORSTA FILTERS GOLF COURSE IRRIGATION CASE STUDY – MOSINEE, WI

Forsta Filters Golf Course Irrigation Case Study – Mosinee, WI

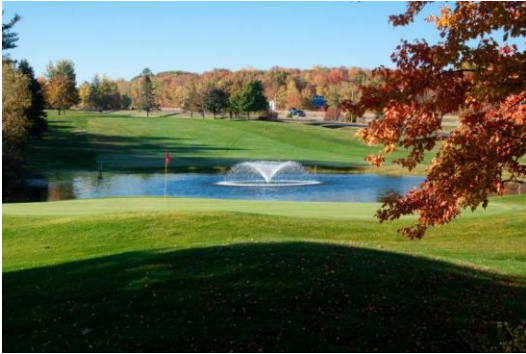
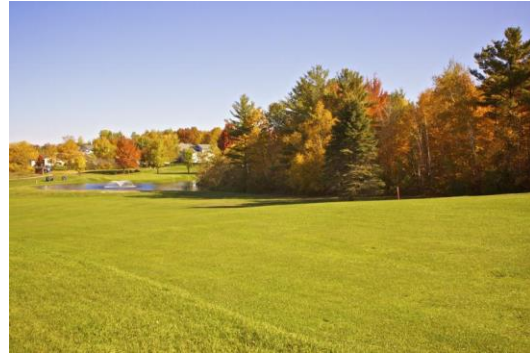
The B6-180 model filter was installed at the pump discharge in early 2010. The filter was positioned at the discharge of the pump in order to best utilize the available line pressure to power its point-of-suction backwash cycle. This unique approach to backwashing ensured that even while cleaning itself, filtered water

The golf course pump station flows 900gpm in a 6-inch line at 110psi. Based on these parameters, Forsta engineers proposed the B6-180 model filter which would provide 5.25 sq ft of screen area. A 200 micron (70 mesh) screen was selected to protect the sprinkler heads from the sand and other debris that had been disrupting the system.

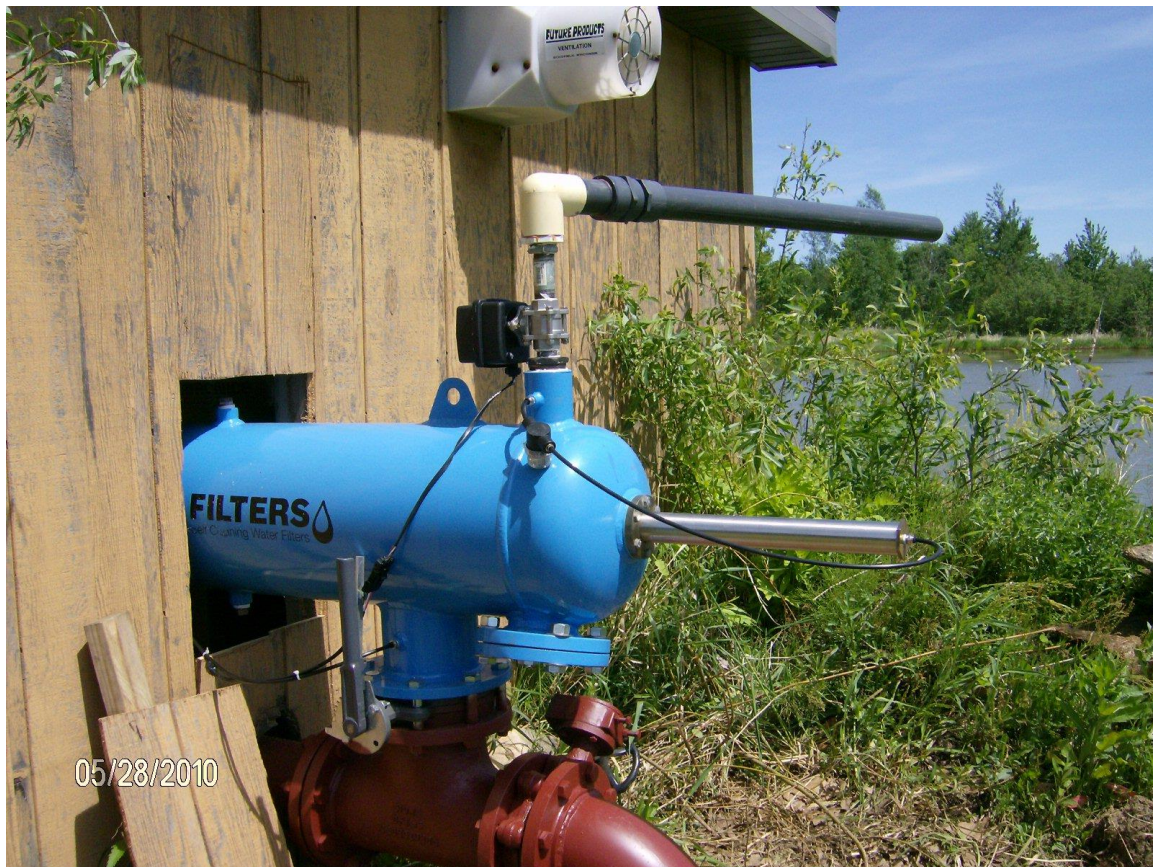
would continue to flow. The continuous flow of the Forsta self-cleaning filter eliminated the need for standby filters and complex valve schematics, frequently needed with other types of filters.
