# Small Scale Carp Exclusion Pilot Plant

Paul Anderson M.Sc., Norval Horner P.Eng. and Keith Nesbitt  
**Gull Lake Watershed Society (GLWS)**

October 22, 2020

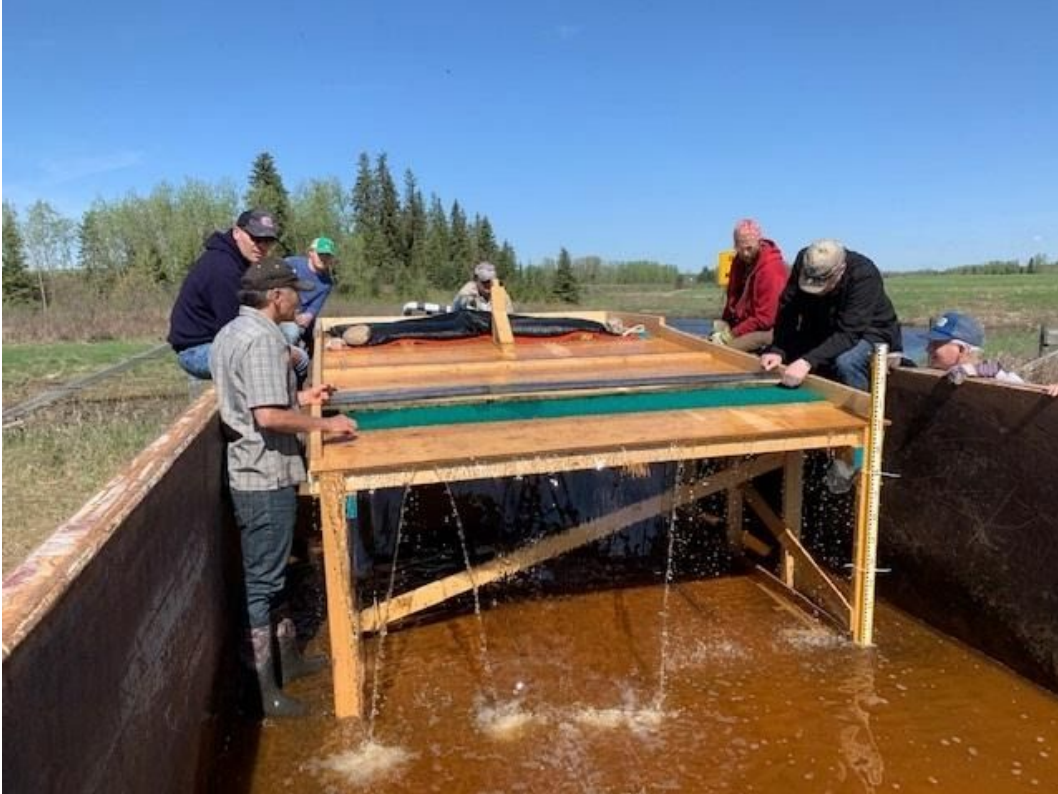
The Geotube test apparatus with the sluice set up

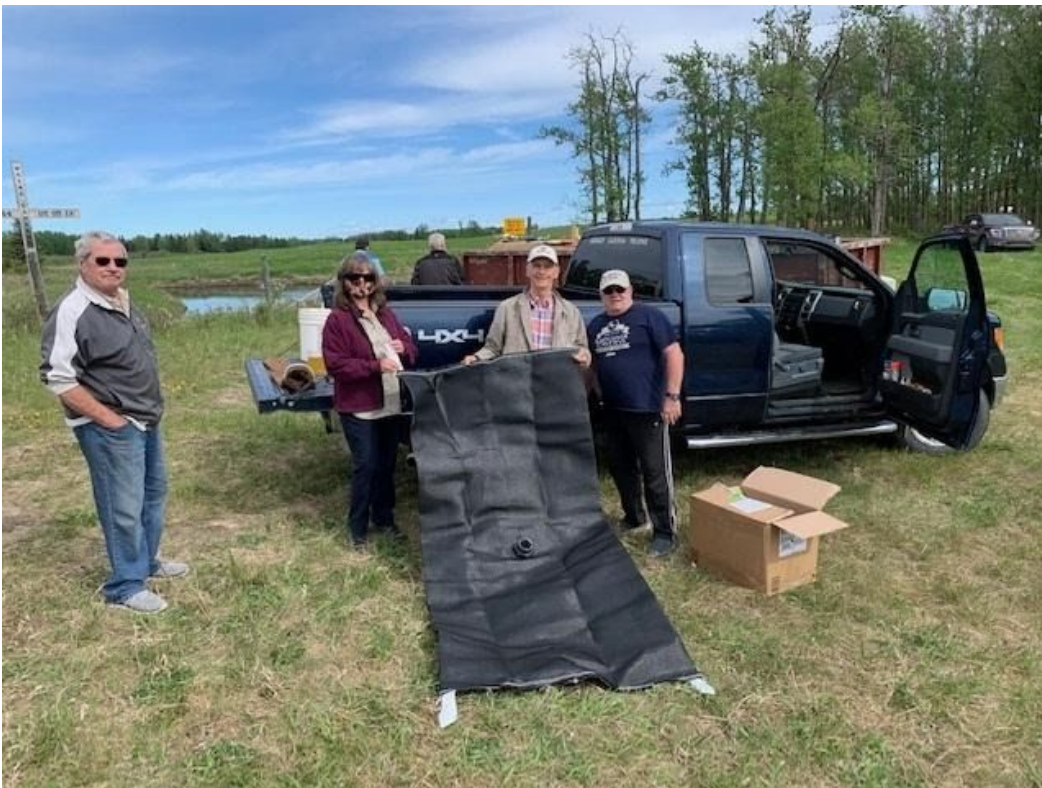
A test size Geotube filter before starting the test note the flanged inlet on top

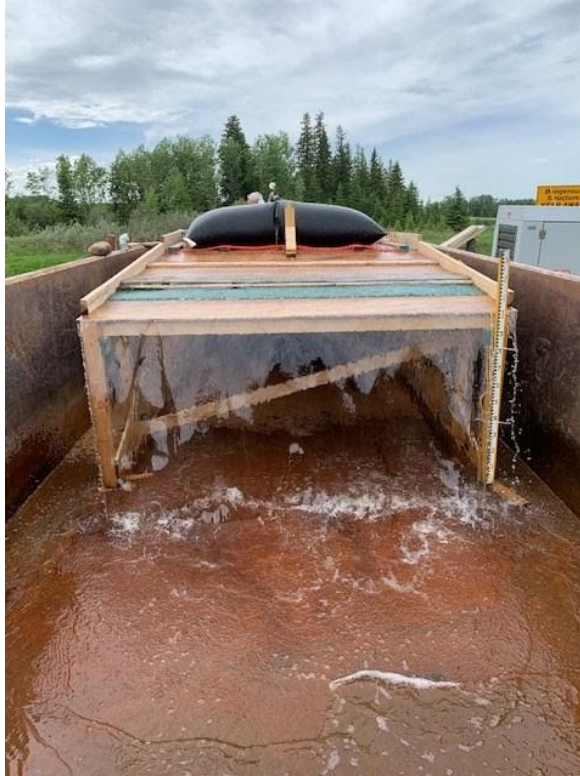
**The inflated geotube being run at full flow rate of about 80 usgpm early in the test**

- c. The first run was also marred by the change to a high pumping rate with the 3 phase 3-inch pump with over 150 usgpm or over 3 usgpm per sf. which is twice the scale flow planned. This flow rate appeared to risk bursting the bag and many pinhole streams were exiting at high velocities from the seams and corners and shooting out up to 2 feet. That was corrected by adding the inlet bypass that allowed the flow through the bag to be brought down to 80 usgpm and pressure on the top of the bag to be controlled to  $\approx$  3 feet of head. Even with the reduced flow, the bag inflated to over 20 inches high in the 36 minute final run and small streams were visible at the seams and around the inlet.

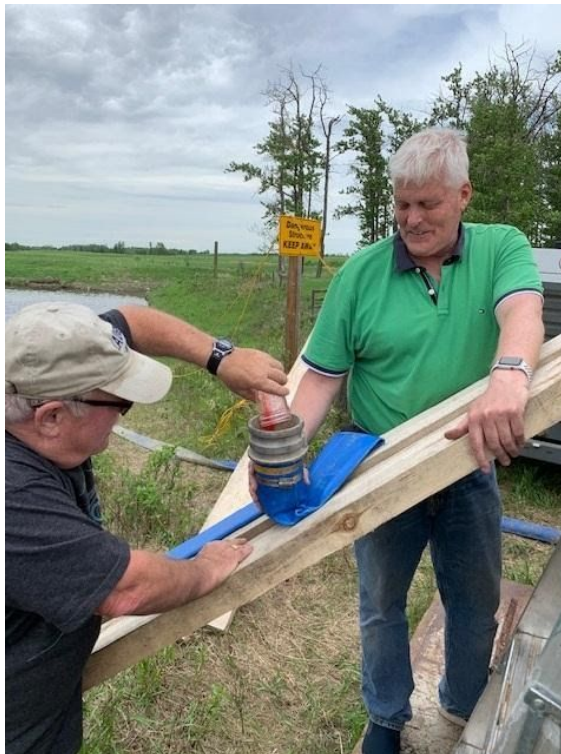
**Adding 5000 dyed Carp eggs to the inlet hose to the Geotube**

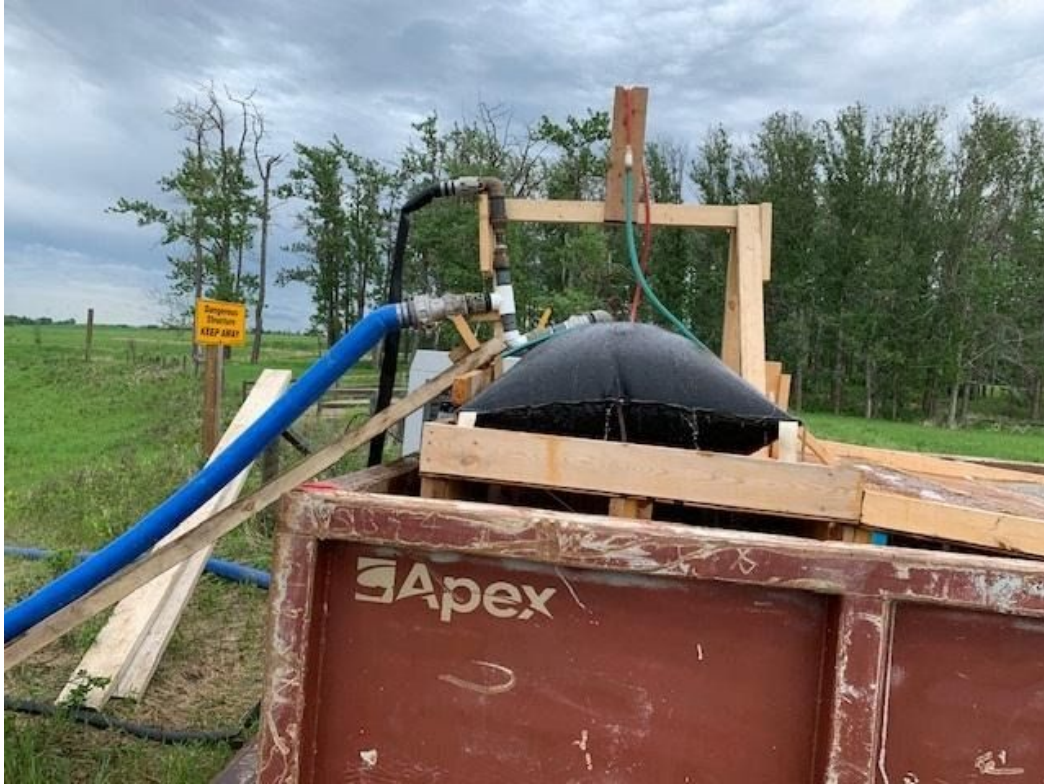
**Final test configuration with a fully inflated geotube showing signs of pressure stress**

- h. We noted that the test Geotubes appeared sensitive to pressure as they became partially plugged and in a full scale scenario pressure would have to be controlled or structural integrity could be compromised. This is not a serious concern in the traditional use of the Geotubes but is a concern where it is essential that no eggs get through. It would be essential to ensure that the Geotube is not overpressured as it is clogged with silt.

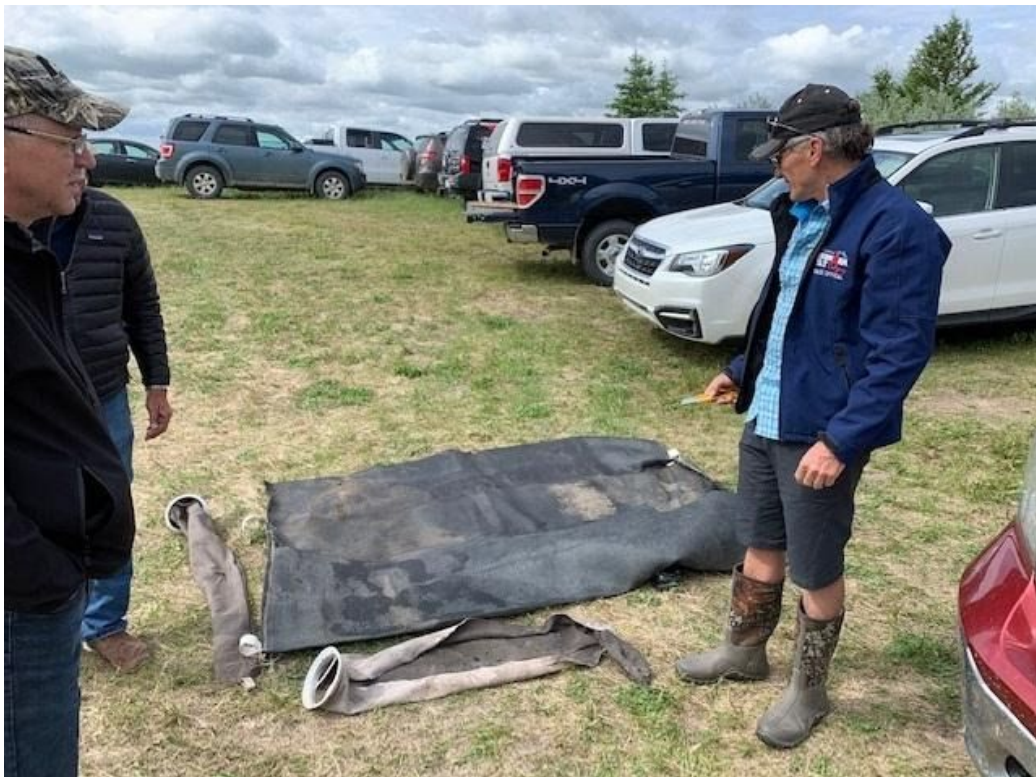
**Inspection of the first Geotube and the downstream SOC filter after test run**

- a. After the run on June 17<sup>th</sup> the second Geotube and the final SOC filter were opened and examined by Paul Anderson using a hand lens. During the examination of the Geotube it was noted that there was a very thin layer of fine claylike material clogging the pores, particularly on the bottom of the bag. No eggs were visible in either the Geotube or the SOC filter. It was surprising that none were visible in the Geotube as over 15,000 brightly dyed eggs had been introduced and none had been observed flowing out of the Geotube down the sluice. The eggs are difficult to see and may be ruptured while pumping them into the bag or dessicate very rapidly if the bag is allowed to dry out before being examined (it had been at least 24 hours between the last test and examination of the bag contents). It was noted that unlike the Geotube, the SOC filter had a buildup of clay-like material, enough that you could scrape out spoonfuls.

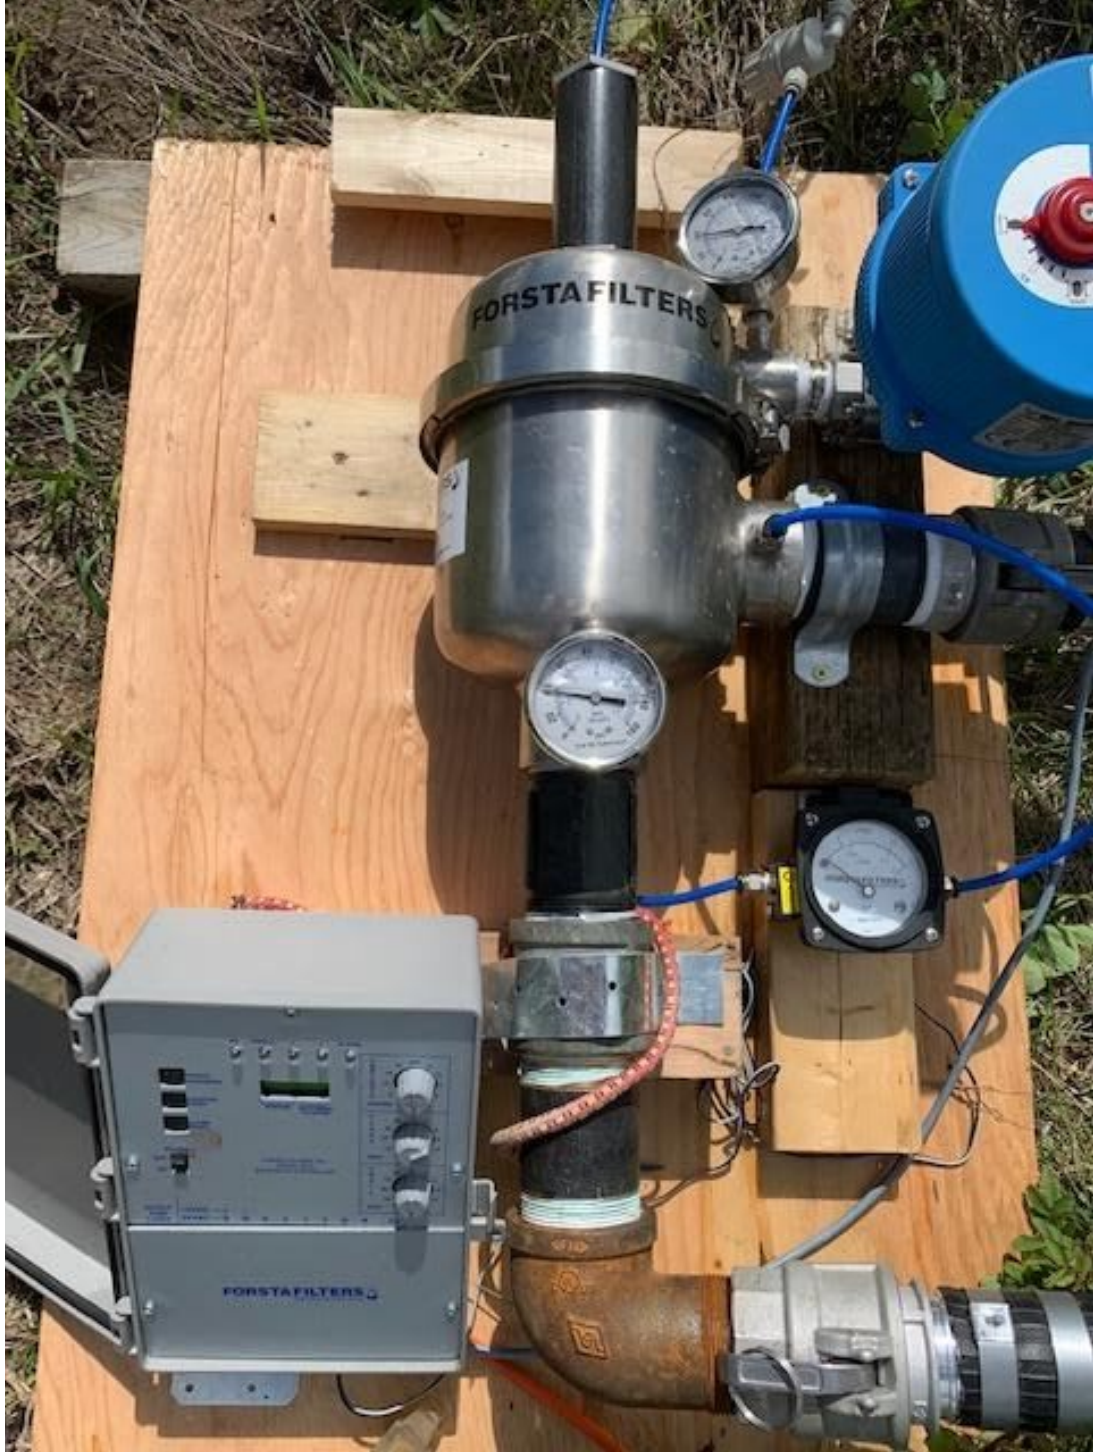
The assembled Forsta filter test system connected to the camlock hoses

The kit was received in early July and assembled according to their detailed instructions. This took some time as the connections had to be adapted for Camlock hose fittings for the inlet and outlet water and wiring was needed to connect the control module to the automatic backwash valve. The components were mounted on a sheet of plywood and the pipes/ connections supported with wooden members. The Forsta filter includes a rotating internal cleaning system designed to ensure an efficient backwash. It also includes a differential pressure gauge that indicates the differential pressure “ $\Delta P$ ” between the filter inlet and outlet. It was factory set to backwash at a differential of 7 psi. A picture of the assembled test kit and an individual filter cartridge is attached.

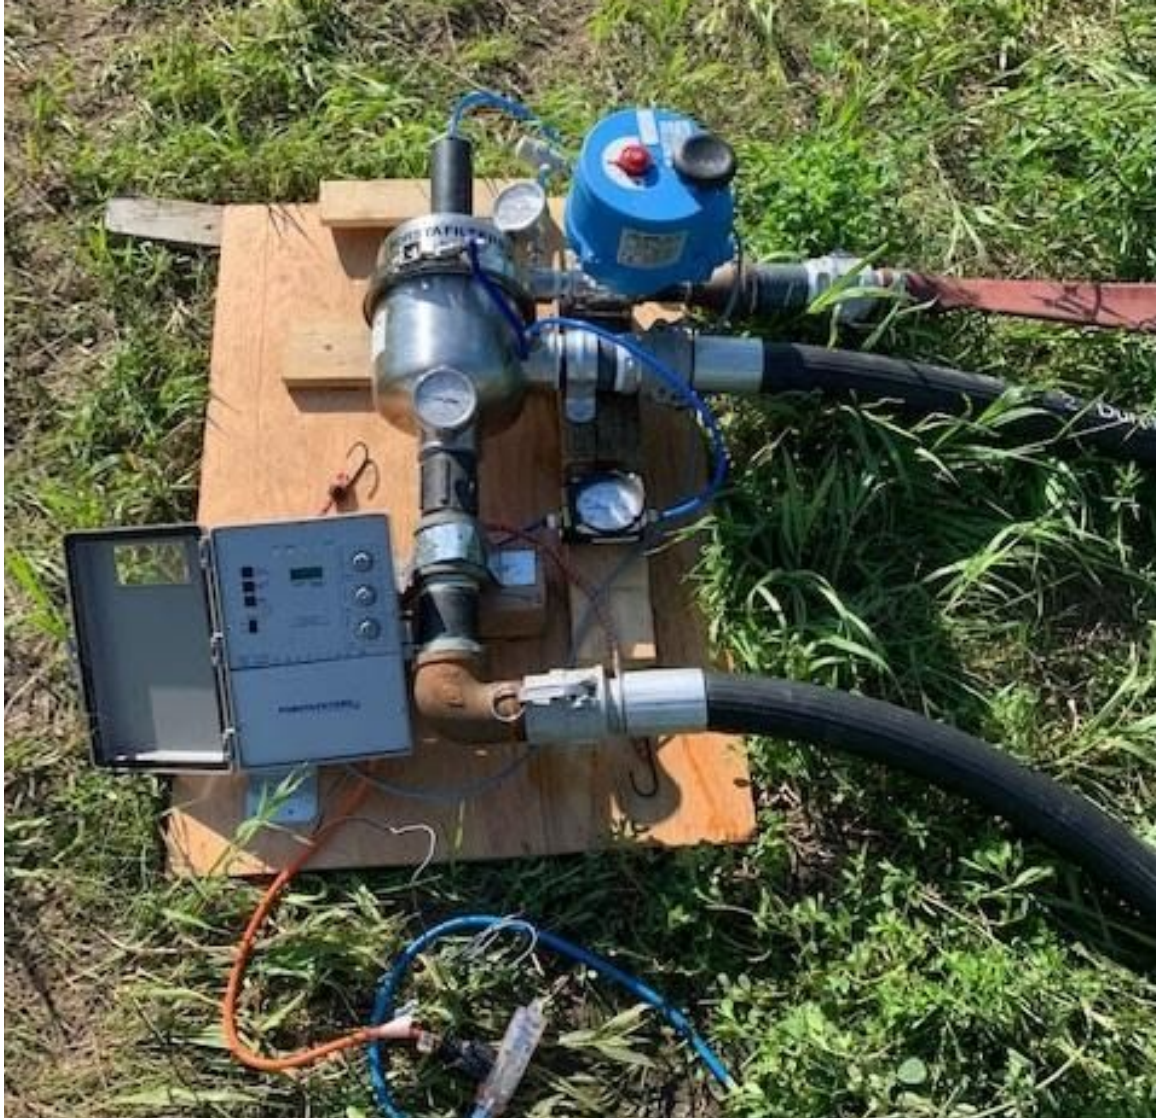
Forsta filter and backwash controller, the lower hose is the inlet, the middle one is the outlet and the differential pressure gauge is between them. The top (red) hose with the control valve goes to the backwash tub. The grey box is the automatic backwash controller.

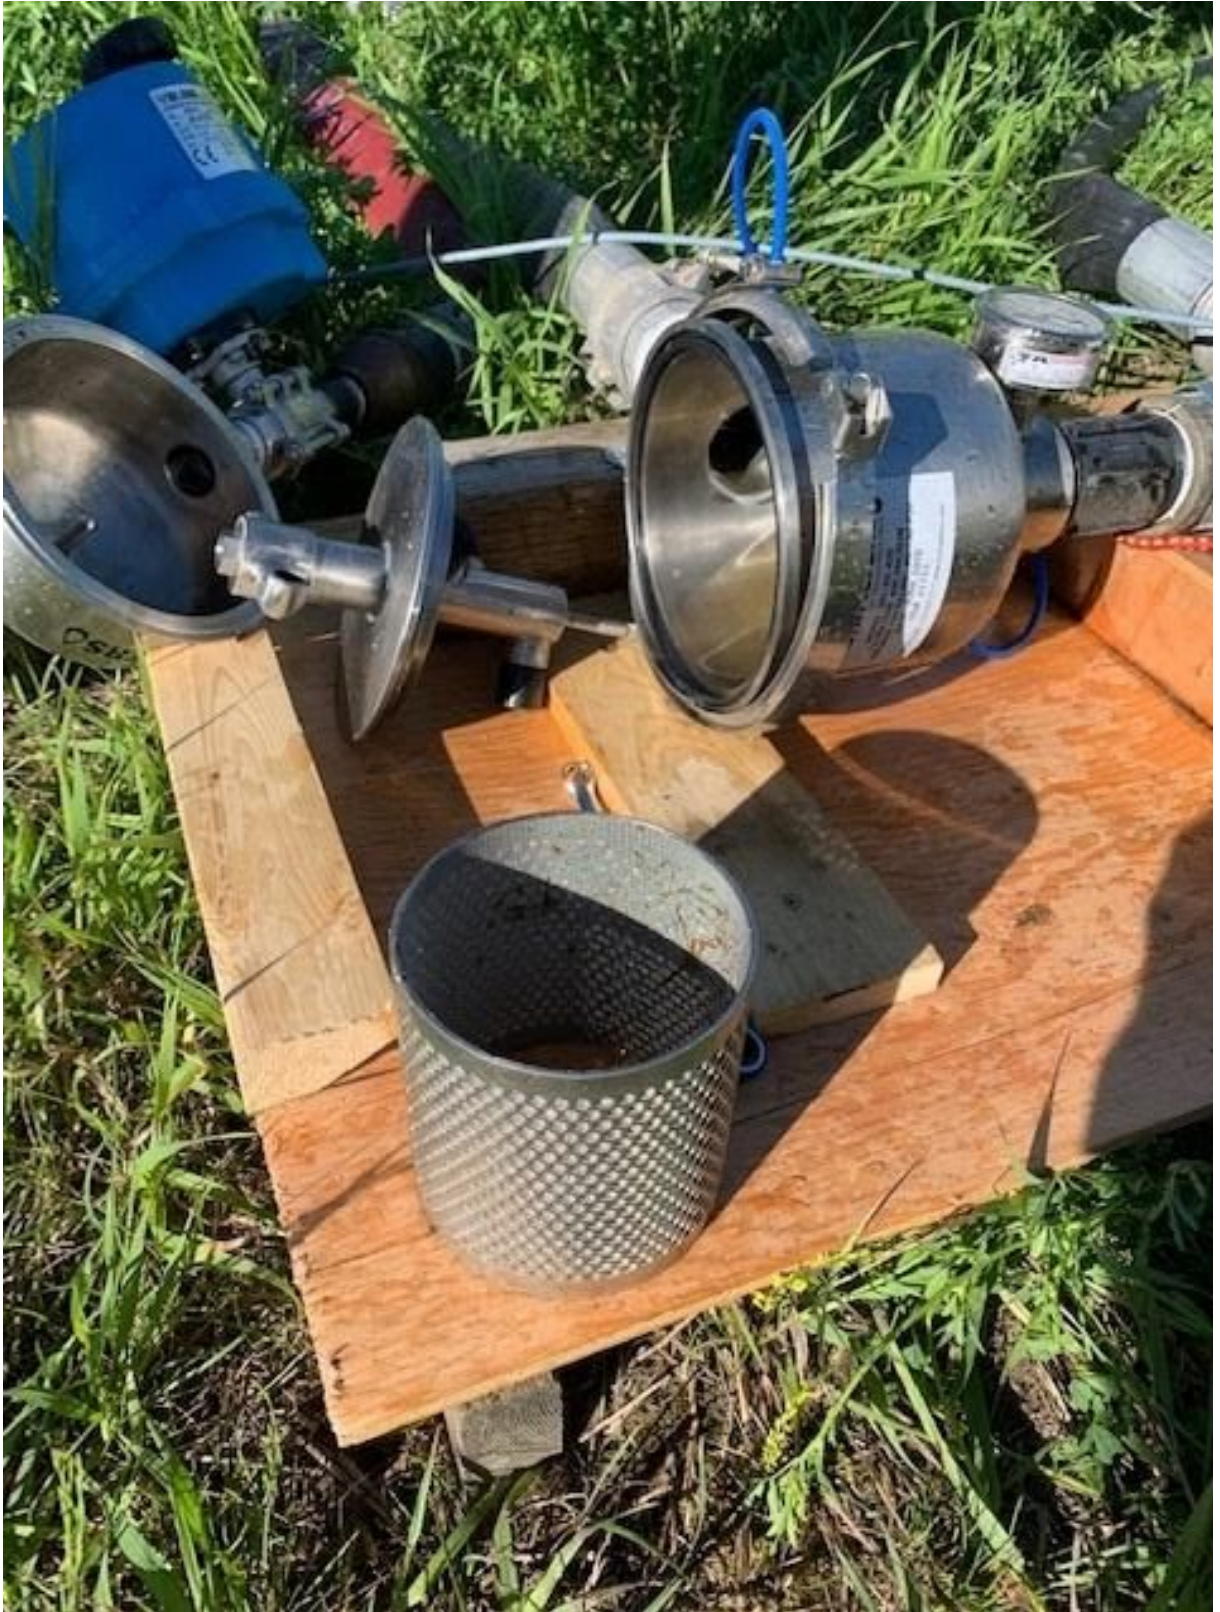
The disassembled filter showing the Forsta Filter cartridge beside the case with the backwash mechanism to the left

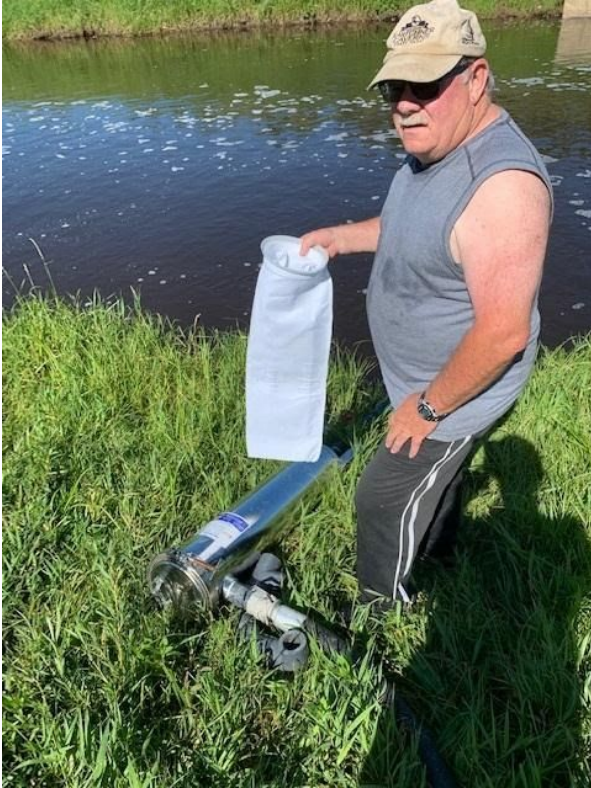
New SOC filter

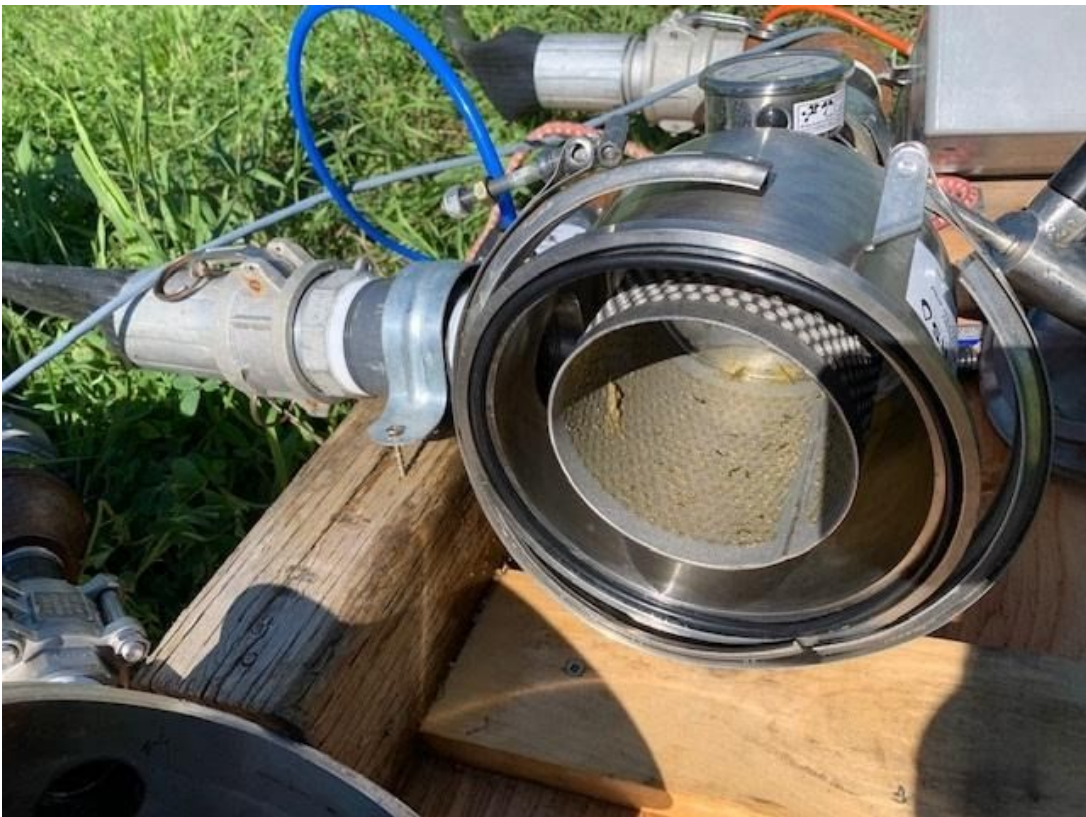
Carp eggs inside filter cartridge

4. It appeared that some aged eggs may have been squeezed through the 400 micron filter. It is important that the filter cartridge be completely sealed with the o rings.

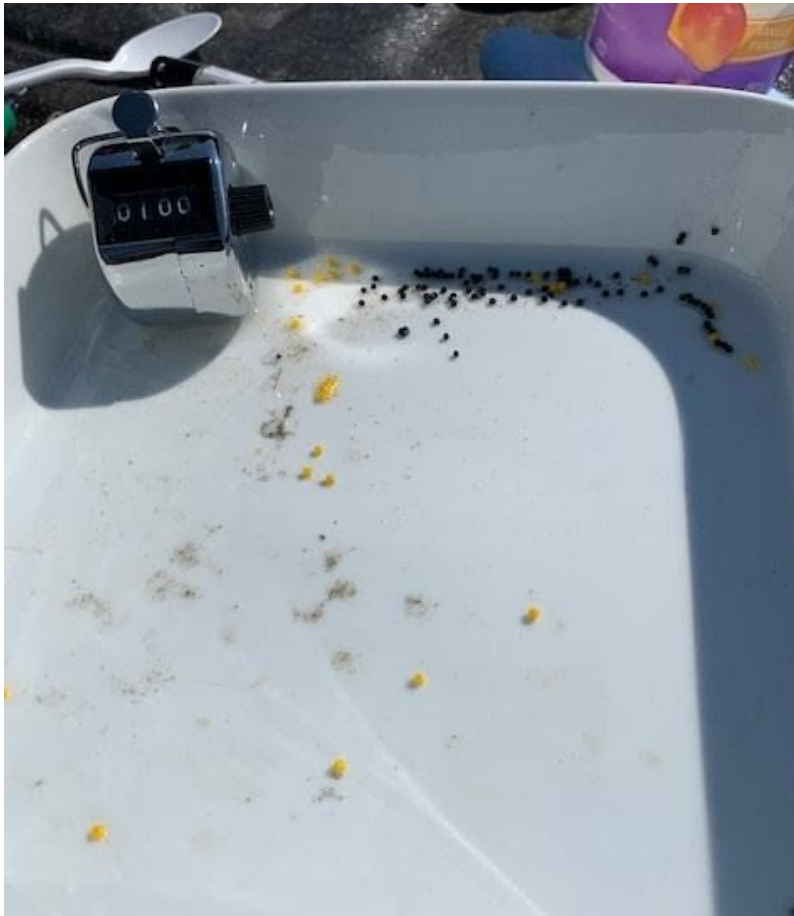
100 small black beads - 100% recovered from the backwash - success
